Kit Instruction— KDACVNORNC

Add Normally Open Clutch Valve 64046E6N, 72058J2N/J5N

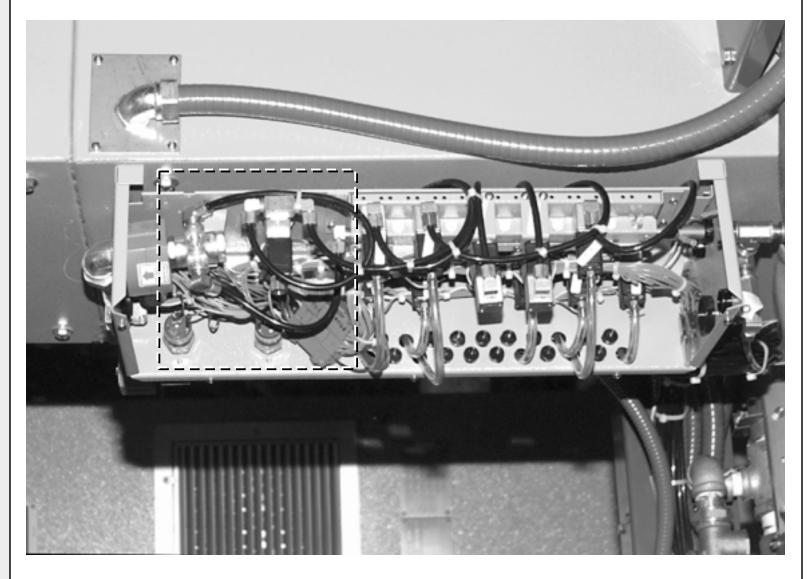
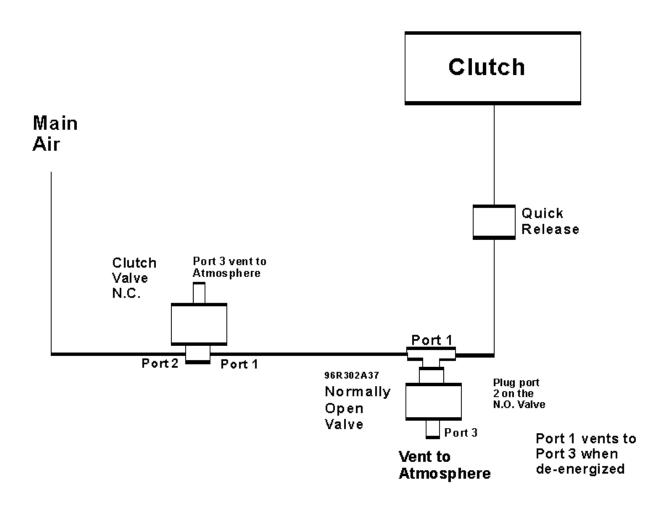
If for any reason the existing clutch valve seat fails, the new normally open valve will allow air to pass through Port 1 to Port 3 and to atmosphere, thus not inflating the clutch.

If the exhaust port (Port 3) on the new normally open valve is passing air when the clutch is not inflated, you must replace or rebuild the normally closed clutch valve immediately. (This is the valve with the green coil.)

- 1. Mount the new normally open, pilot valve directly under the existing clutch valve using the hardware supplied in the kit.
- 2. Wire the new normally open valve in parallel with the coil of the existing clutch valve.

The new normally open valve should have a "T" fitting screwed into Port 1. The existing clutch valve will now be tubed from Port 1 to the "T" fitting. The outlet of the "T" will then lead to the quick relief valve which feeds the clutch.

Port 2 on the new normally open valve will be plugged with a metal pipe plug.

Port 3 of the new normally open valve will be vented to atmosphere.
