Kit Instruction— KLWJRRD001

Instructions for Retrofit Kit: KLWJRRD001 Replacement Door for 36" Washer-Extractors

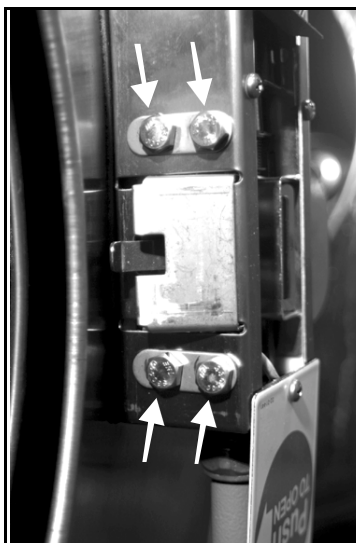
**Figure 1: Latch position
adjustment bolts**

- Loosen the four latch bolts shown in Figure 1. Note the adjustment slots under each latch bolt (shown in Figure 2).
 - Adjust latch as required. Restore power and check for excessive door closing effort and water leaks after each adjustment.

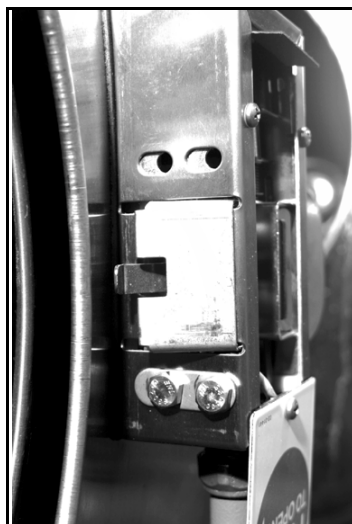
**Figure 2: Adjustment bolts
removed, showing slotted
adjustment**

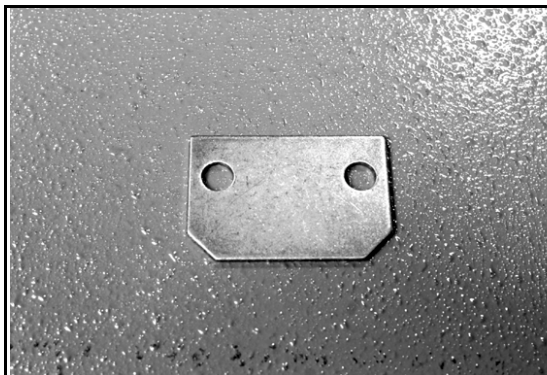
Figure 3: Additional thin shim removed from the discarded door

5. If the door continues to leak after the latch has been adjusted then disassemble the striker mechanism of the old discarded door and remove the thin shim shown in Figure 3.

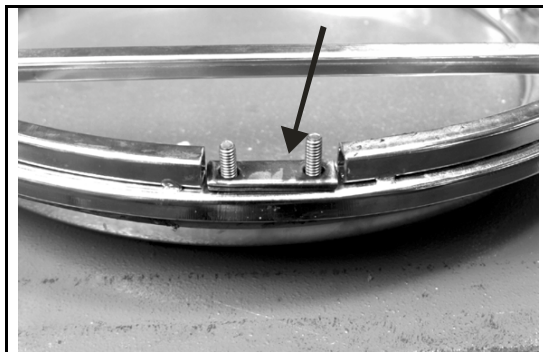
Figure 4: Where to add thin shim

6. Disassemble the new door striker mechanism and add the thin shim where shown in Figure 4. Reassemble the door striker and test.
