Kit Instruction— KDACVNORNC

Add Normally Open Clutch Valve 64046E6N, 72058J2N/J5N

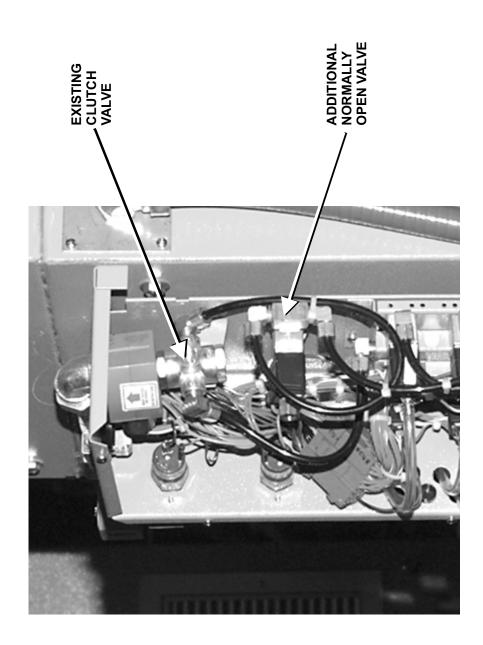
If for any reason the existing clutch valve seat fails, the new normally open valve will allow air to pass through Port 1 to Port 3 and to atmosphere, thus not inflating the clutch.

If the exhaust port (Port 3) on the new normally open valve is passing air when the clutch is not inflated, you must replace or rebuild the normally closed clutch valve immediately. (This is the valve with the green coil.)
