Kit Instruction— KZSCP00100

FLUSHING WATER SEALS AND LEAK - OFFS IN 52" AND LARGER WASHER-EXTRACTORS

MSSM0271AE/9704AV

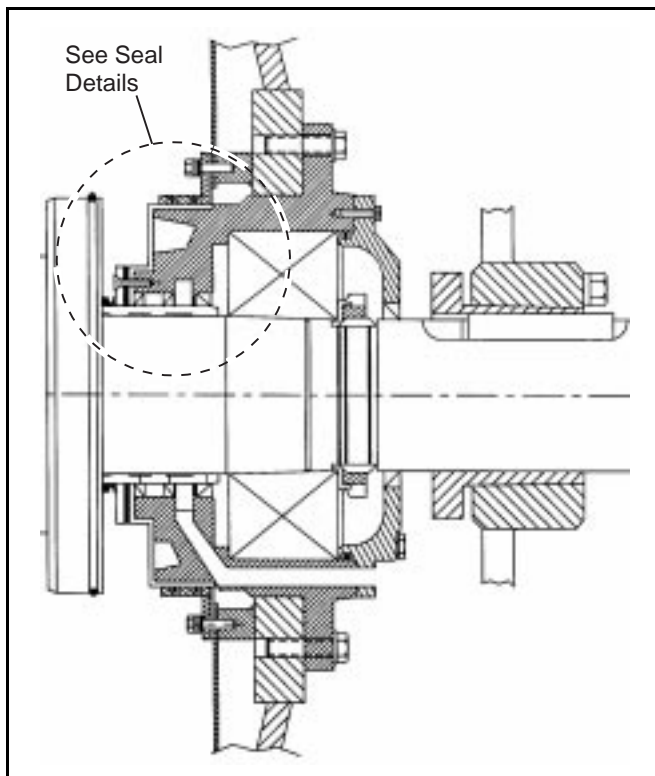
FIGURE 1 (MSSM0271AE) — Typical Bearing Housing for 52 through 72 Washer-Extractors

Background Information—The grease filled bearing housings for 52 inch and larger machines are supplied with two water seals and a grease seal as shown in FIGURES 1 and 2. Bath liquor is prevented from entering the bearings by two water seals separated by grease filled cavity (FIGURE 2). Any water leaking past the water seals is drained by the leak-off cavity. The grease seal retains the grease in the housing. The seal grease cavity and the leak-off cavity can become clogged with lint and debris, resulting in seal and bearing failure. Every six months, flush out these cavities with mineral spirits, as described within. Normally, flushing is done less often than greasing. However, whenever flushing is due, it should be done just prior to greasing, during the same maintenance session.

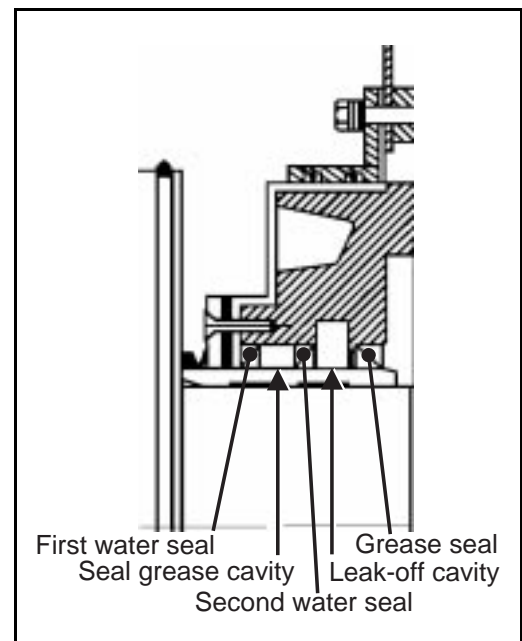
FIGURE 2 (MSSM0271AE) — Seal Details

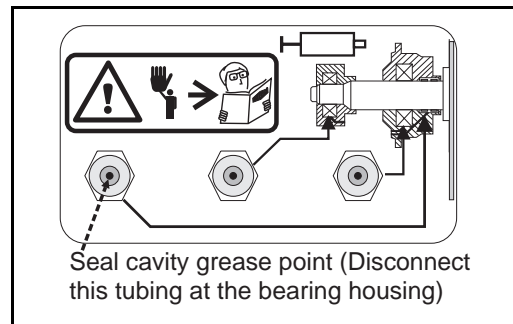
FIGURE 3 (MSSM0271AE) — Identifying the Seal Cavity Grease Point

1. Locate the tubing running from the seal cavity grease point to the bearing housing (FIGURE 3). Disconnect this tubing at the bearing housing.
2. Install the bulb pump.
3. Remove the seal cavity grease relief fitting (if so equipped) to prevent the mineral spirits and contaminated grease from being pushed back into the shell under the first water seal. FIGURE 4 shows the internal passage from the seal cavity grease inlet to the seal grease cavity (FIGURE 2) and the internal seal cavity relief passage from the seal grease cavity to the grease relief fitting (if so equipped) on the housing.
4. Flush until the mineral spirits dripping from the seal cavity grease relief are clear (approximately two quarts - 1.9 liters).
5. Re-install seal cavity grease tubing and grease relief fitting (if so equipped).

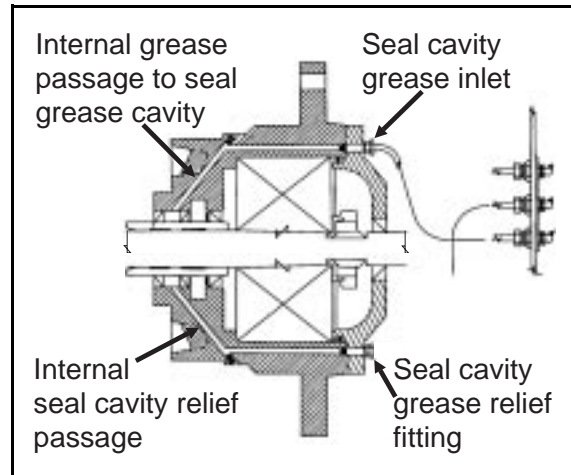
FIGURE 4 (MSSM0271AE) — Internal Seal Grease Cavity Passage and Relief

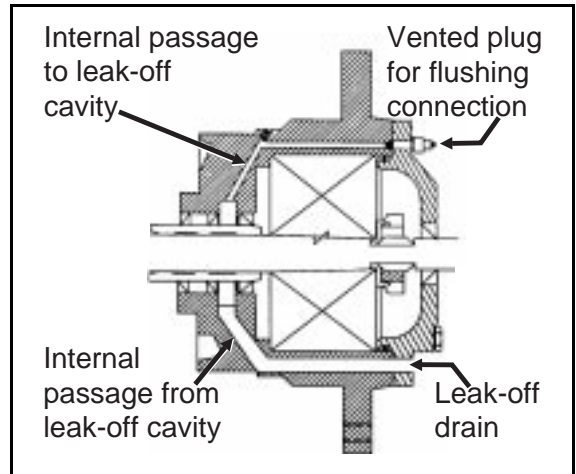
FIGURE 5 (MSSM0271AE) — Internal Flushing Passage and Leak-off

1. Remove the vented plug at the flushing connection and install the bulb pump.
2. Pump approximately two quarts (1.9 liters) of mineral spirits into the flushing connection until the spirits flow easily out of the leak-off drains. FIGURE 5 shows the internal passage from the flushing connection, through the leak-off cavity, and the internal drain to the exterior of the housing.
3. After flushing, replace the vented plug, then see "Greasing Seals and Bearings" in the Preventive Maintenance section.
