HIGH SPEEDS CAN DAMAGE FIREFIGHTER TURNOUT GEAR

By: Darrell Redler, Pellerin Milnor Corporation

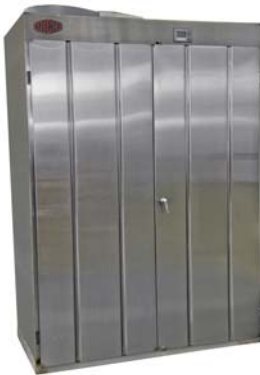
drying instructions from the gear supplier for guidance on drying since many gear suppliers prohibit tumble drying due to the potential for damage to various elements of the ensemble. Milnor solves this problem by offering an all-stainless steel drying cabinet in two size capacities: the 40"-wide model for up to 3 sets of gear; and the 61"-wide model for up to 6 sets. The Milnor drying cabinet uses directed hot airflow (instead of the mechanical action of a tumble dryer) to quickly return the clean gear to useful service (typically in about one hour). Otherwise, simple hang-drying (perhaps aided by a ventilation fan) also works, but takes more time.
